# An Environmental Profile of the Island of Virgin Gorda, British Virgin Islands

A Report of Island Resources Foundation

2012

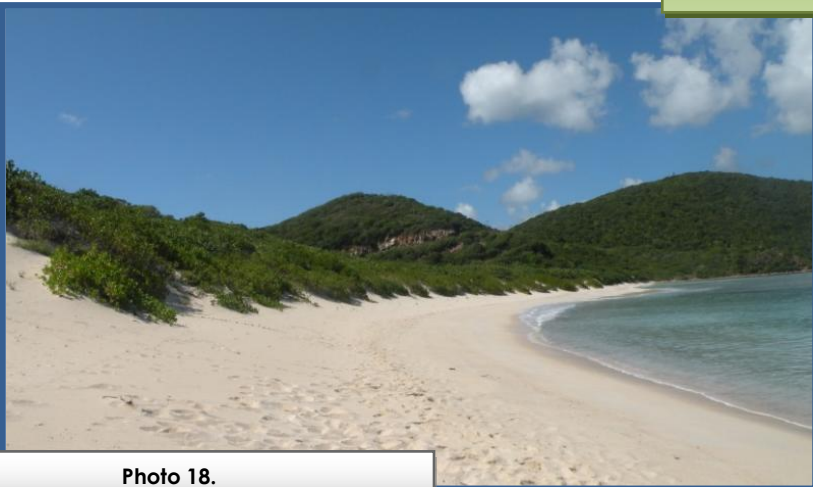
**Photo 18.**  
Largest and most impressive beach and dunes system in Virgin Gorda located along Savannah Bay.

Virgin Gorda and its surrounding island and cays are endowed with an extraordinarily scenic and diverse coastline, a product of its geological history, topography and ocean dynamics. Here one finds dramatic rugged cliffs with numerous embayments marked by sandy beaches and, in some areas, quiet shorelines fringed with mangroves. Most impressive are the cliffs extending about 50 m (164 ft) above sea level along the southeastern coastline of the eastern peninsula (**Photo 16**), while the largest stretches of fringing mangroves occupy both sides of Deep Bay (**Photo 17**). Without exception, the most impressive beach system in the Profile islands lies within Savannah Bay (**Photo 18**).

Savannah Beach (**Photo 18**) is the largest and most impressive beach formation within the Profile area. It lies between the central landmass and Minton Hill (south peninsula), forming part of an isthmus between the two (**Figure 6**).

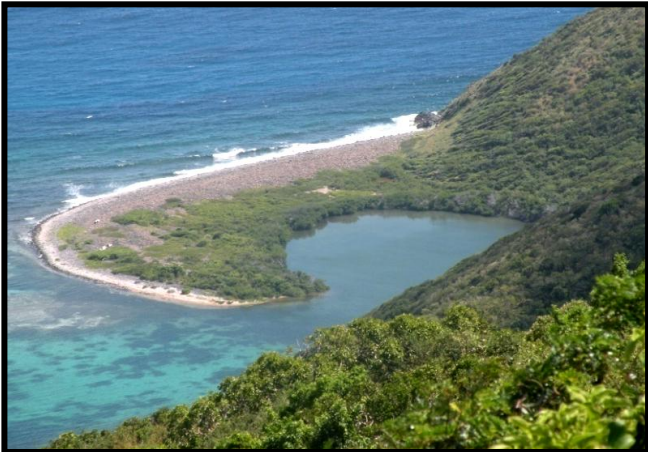
**Photo 19.**

South Sound spit composed of coral rubble. Note the heavy surf.

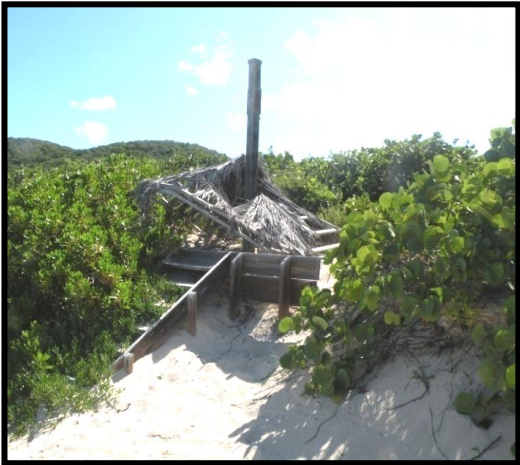
**Photo 20.**

A bohio shelter that has collapsed due to shifting sand dunes from the land side and seasonal storm waves from the water side. Beach vegetation is slowly covering the site and provides some stability.

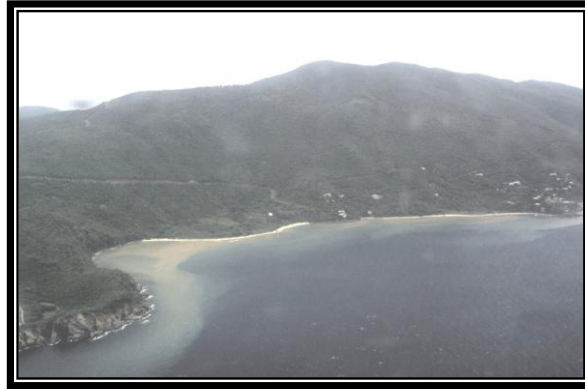
**Photo 26.**  
Severe sedimentation from 2003 flooding at Nail Bay, Virgin Gorda.

Increased sediment delivery to nearshore waters is a key stress on coastal ecosystems. Increased sedimentation can cause a variety of negative impacts on coral reefs, including screening light needed for photosynthesis, scouring of coral by sand and sediments, poor survival of juvenile coral due to loss of suitable substrate, and direct smothering of coral in cases of extreme sedimentation.

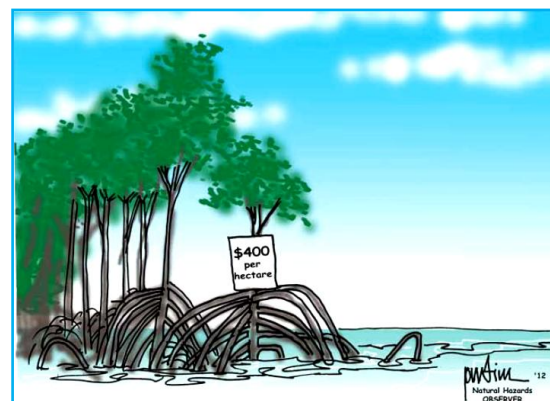
**Figure 13.**

One assessment of the value of mangroves (source: *Natural Hazards Observer*, 2012).

One analysis places a dollar value on mangroves at a healthy \$400 per hectare (*Natural Hazards Observer*, 2012, **Figure 13**). In contrast to this stated economic worth of wetland resources, a local scientist in the BVI has asserted that more than 84 percent of the territory's original salt pond wetlands has already disappeared (Jarecki, 2004).

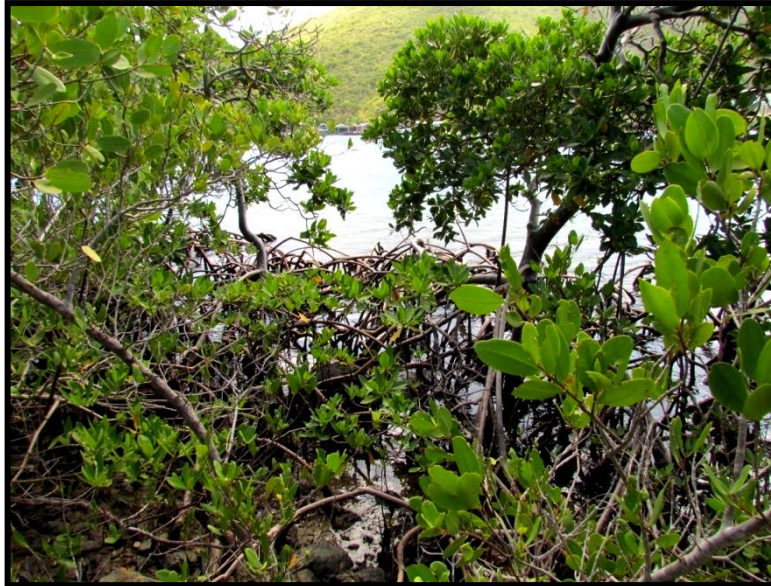
**Photo 27.**  
Coastal red mangrove woodland at Biras Creek, Virgin Gorda.

Most of the coastal wetlands around Spanish Town, at Little Dix Bay, and other Virgin Gorda locations have been filled or significantly altered. **Photo 27** shows a typical area of fringing coastal mangrove woodland along Biras Creek.

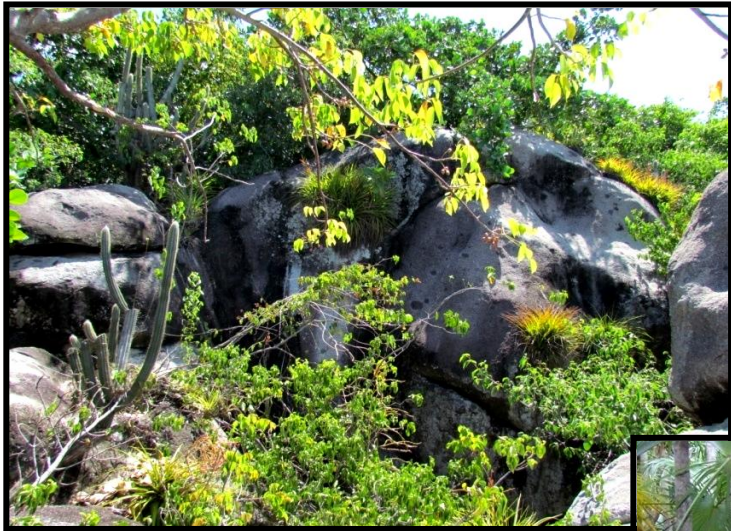
**Photo 28.**

Vegetation located in the northern sections of the boulder fields, Virgin Gorda, covered with bromeliads, orchids, cacti, and trees growing on rocks.

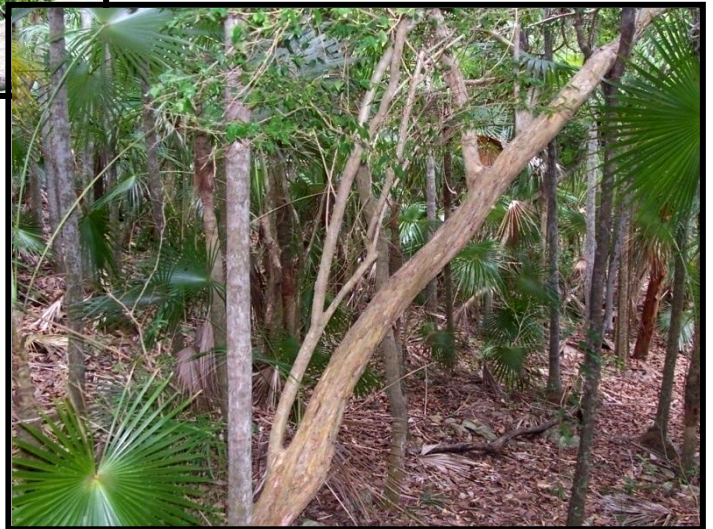
**Photo 29.**

Evergreen palm forest (commonly named broom palms) along the northwestern slopes of Mosquito Island.

In the past, this palm would have formed extensive evergreen forests, mixing with the more common *Coccothrinax barbadensis*, which was highly prized early in the last century to make baskets, hats and other local materials. On Virgin Gorda, this species is now quite rare and absent from most of the island. **Photo 29** shows the evergreen palm forest on Mosquito Island.

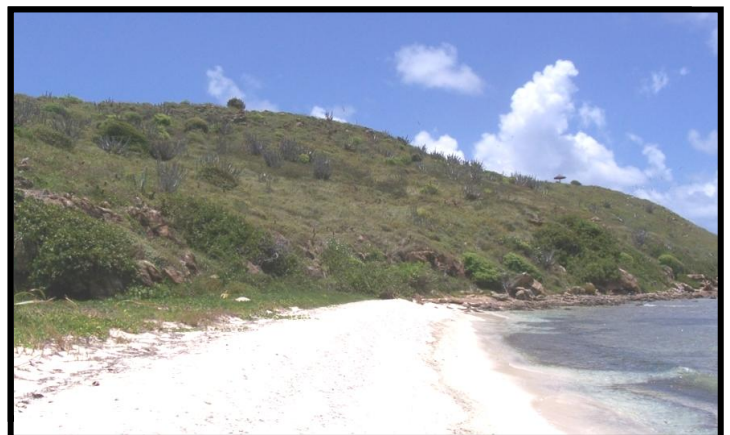
**Photo 30.**

Vegetation on northern section of Necker Island.

Although **Necker Island** is now a resort, much of it is undeveloped. Its vegetation is somewhat similar to Eustatia, though grasslands and open shrublands are more widespread (**Photo 30**).

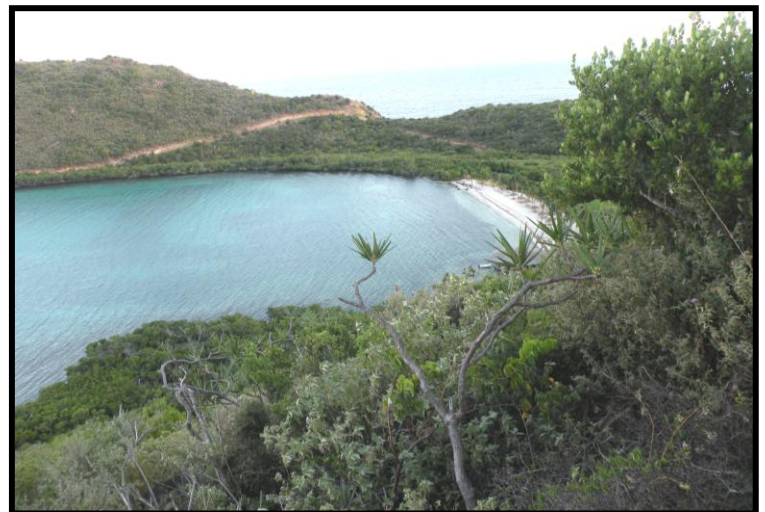
**Photo 31.**

Dry coastal woodland and scrub at Deep Bay, Virgin Gorda, where many rare and threatened native species persist. The view is from Biras Hill looking toward Deep Bay Beach with the Oil Nut Bay road visible on the hillside.

These systems are dominated by thorny shrubs, a few small trees, orchids, grasses, sedges and cacti. Despite this, dry scrub and woodlands on the eastern peninsula (**Photo 31**) and offshore islands are critical to the continued survival of these rare Caribbean coastal dry plant habitats.

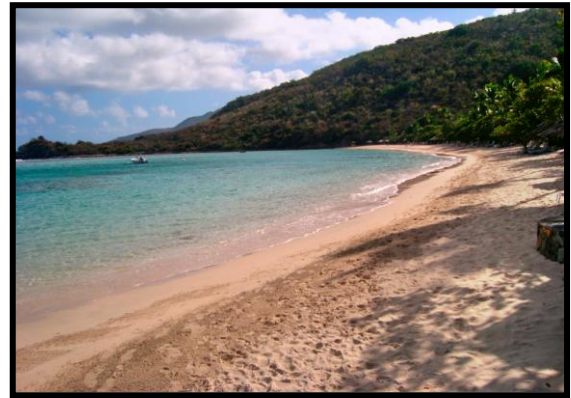
**Table 6.**  
**Recent storms and hurricanes in the BVI.**

The northwest-facing beach at Little Dix Bay on Virgin Gorda's western coast. The environment is illustrative of physical environment #1 in the text.

- (1) The north and west coast contains extensive beaches that are most affected by winter ground seas. There are many sand beaches and offshore reefs dominated by soft corals (**Photo 62**).
- (2) The south coast tends to be impacted by open Caribbean Sea conditions throughout the year. Continuous wave action erodes the coastline producing impressive cliffs and rocky shores. The harsh conditions create an underwater topography of eroded boulders and bedrock. Hard corals thrive in this exposed environment (**Photo 63**).
- (3) The extensive sheltered waters of North Sound and its surrounding islands produce calm conditions more suited to seagrasses and algal flats. The bottom is primarily sand and soft sediments that experience little disturbance, except in a few areas (**Photo 64**).

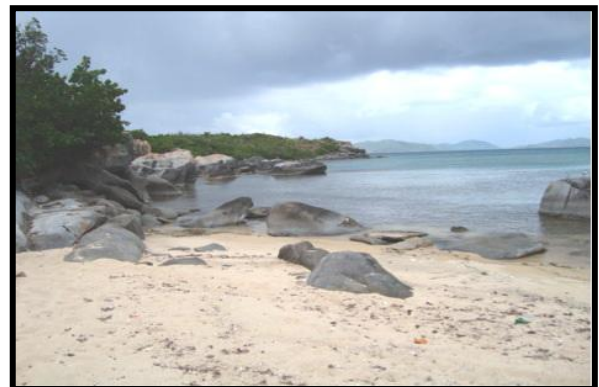
**Photo 63.**

Granite boulders along the southeastern shore near The Baths, indicative of physical environment #2 in the text.

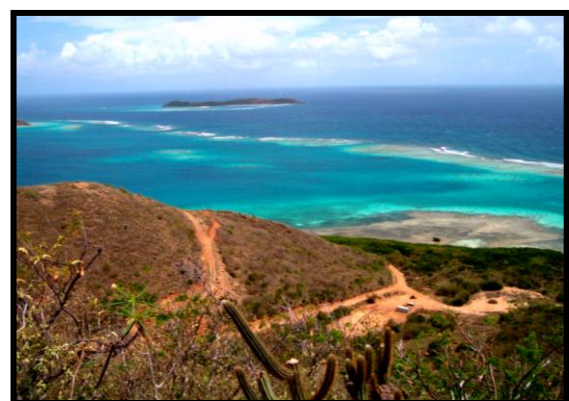
**Photo 64.**

Eustatia Reef shelters North Sound ocean waves (illustrative of physical environment #3). Extensive seagrass habitat behind reef.

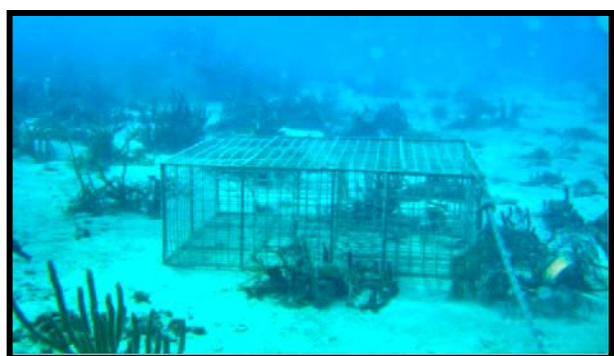
**Photo 65.**

Lost “ghost trap” still able to catch fish.

Trap loss is a serious concern because they continue to function as “ghost traps” and can impact local fish communities (**Photo 65**). The problem is made worse by the lack of escape gaps or biodegradable panels and the attachment of sacrificial anodes to reduce corrosion of the metal. Thus, lost traps can continue to remove fish from the ecosystem for months, or longer. The magnitude of the problem for Virgin Gorda is unknown, but worthy of further study and possible mitigation efforts.

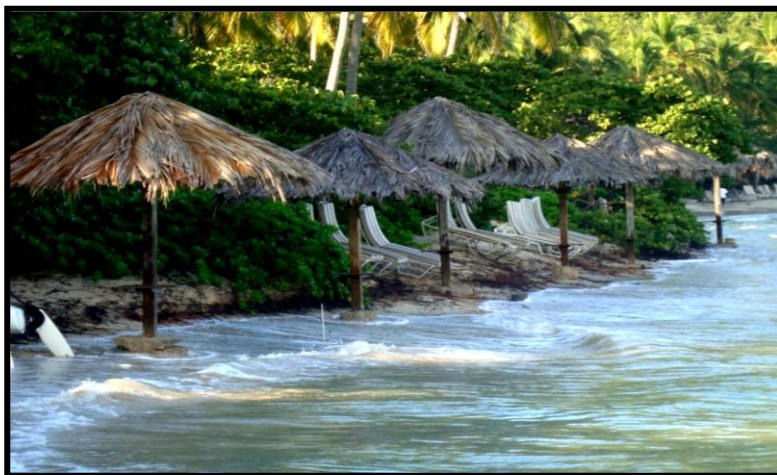
**Photo 67.**

Seasonal beach erosion at Little Dix Bay due to winter ground seas. The water line should be about 6 m (20 ft) from the beach shelters.

Sometimes winter ground seas will remove nearly all the sand from a beach and move it offshore. From an environmental perspective, this is not an issue. In time, conditions will change and sand will be re-deposited naturally, with the beach restored to its former beauty. Of course, tourists do not generally appreciate these natural cycles and will be disappointed if the beach at their world-class resort suddenly vanishes—especially when this natural occurrence seems to take place frequently in the winter tourist season. This happens occasionally at the Little Dix Bay Resort on Virgin Gorda's west coast (**Photo 67**).

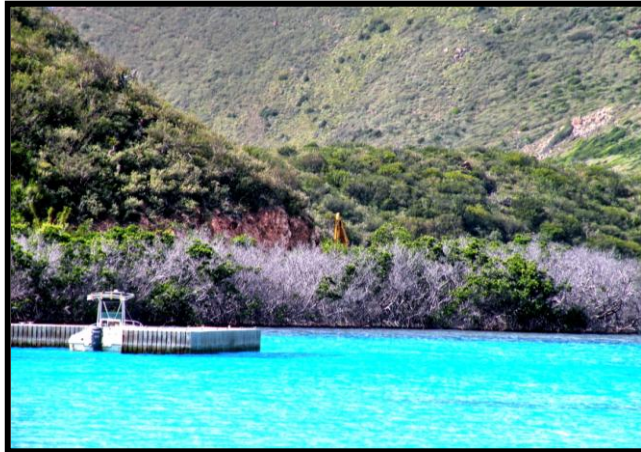
**Photo 69.**

Significant Red Mangrove die-off along the south shore of Deep Bay is likely due to the impact of coastal developments, combined with the adverse effects of severe storms and storm surges.

concrete dock and the expansion of the road, has likely contributed to a loss of fringing mangrove cover (**Photo 69**). In addition, recent hurricanes may have also exacerbated and contributed to mangrove loss, as indicated in the monitoring reports of ONB's environmental consultant.

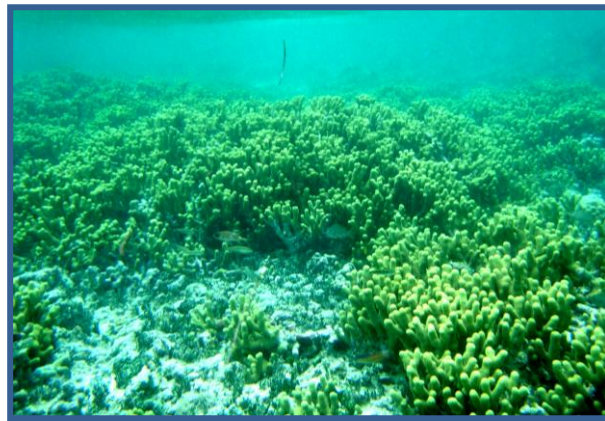
**Photo 71.**  
Finger Coral reef at Deep Bay.

In the back-reef zone between Oil Nut Bay and Deep Bay, there is a shallow shelf extending offshore as part of the alluvium from the land. Along the edge of the shelf is a delicate shallow reef of Finger Coral dominated by the genus *Porites* (**Photo 71**). An environmental report prepared by Petrovic in 2001 described the reef in glowing terms as one of the best intact reefs in the region. Such an undamaged shallow reef of delicate coral species is very rare in the Virgin Islands and probably the best example of such a reef near Virgin Gorda.

Unfortunately, because the reef is shallow and unmarked, there has been considerable mechanical damage by vessels in recent years. Much of the damage probably resulted from the increased boat traffic associated with nearby developments. Given the fragile nature and rarity of such reefs, it should be clearly marked and identified immediately to reduce further damage. Without some form of protection, the entire reef could be reduced to rubble within a few years.

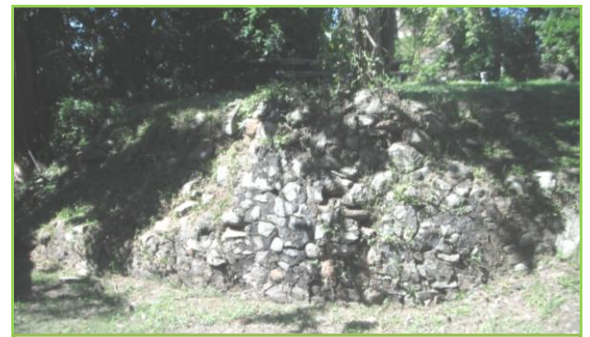
Photo 72. Nail Bay I Sugar Works.

The circular shape of the animal round or mill round can for the most part be traced. Retained edges contiguous to the boiling house are in some places intact with the lime mortar rendering still present (**Photo 72**). Much of the structure has been corrupted, however, by the roots of two trees in particular which have matured on top of the platform.

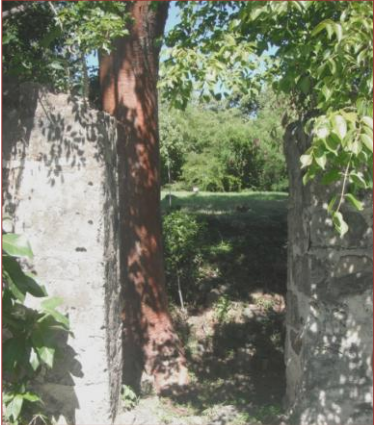
Photo 75. Nail Bay I Sugar Works.

The boiling house is immediately to the side of the animal round and has a doorway aperture providing access between the two (Photo 75). The structure is composed from a variety of materials including, for the most part, Andesite stone; ashlar blocks, which display no markings to suggest they were sawed but are skillfully carved; and red brick (Photo 76).

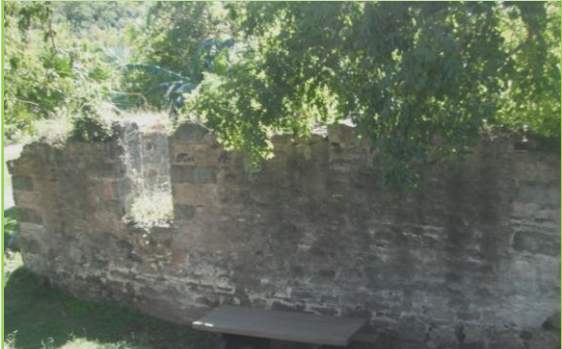
Photo 77. Nail Bay I Sugar Works.

Adjoining this wall, at a right angle running parallel to the animal round, is another wall, which is in far better condition and contains a window aperture (Photo 77).

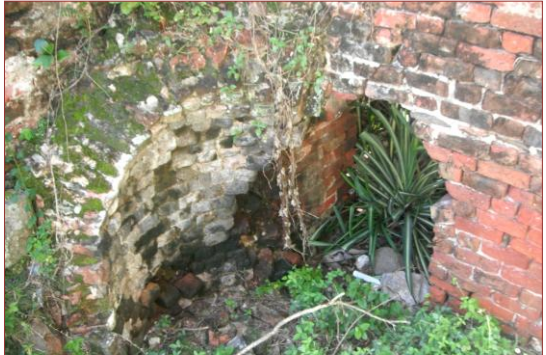
Photo 78. Nail Bay I Sugar Works.

The far end of the copper battery, where the hottest copper was located, has been rebuilt on a number of occasions, and the brickwork displays evidence of exposure to intense heat (Photo 78).

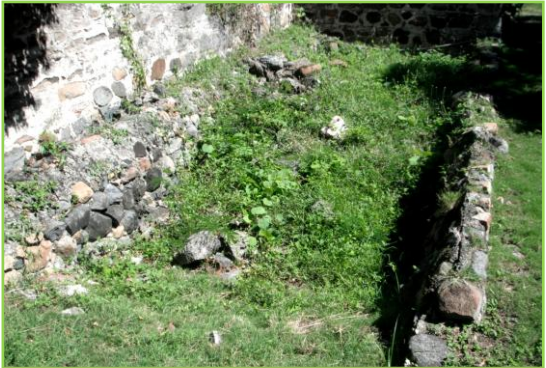
Photo 79. Nail Bay I Sugar Works.

To the rear of the copper battery wall, a rectangular depression in the ground can be seen; it would have contained a shallow wooden tray (Photo 79). Once the cane juice had been reduced as much as possible by heat, the syrupy

molasses would be “struck” or removed from the last and hottest copper, then poured into the wooden tray to dry and crystallise. From here the sugar would be placed into barrels with holes in the bottom and stacked into the curing house.

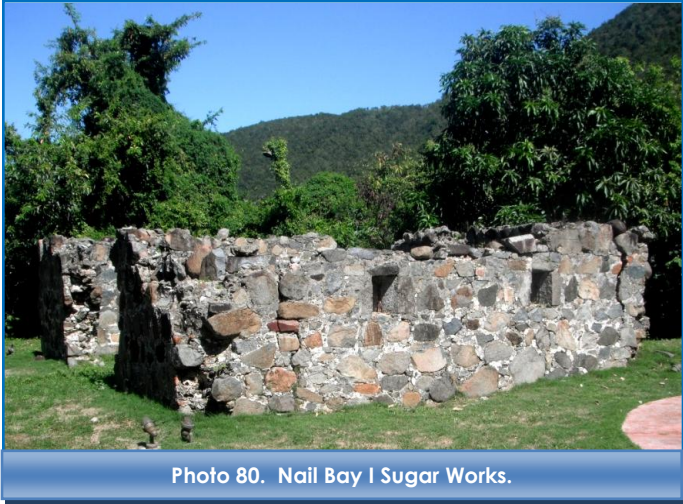
Photo 80. Nail Bay I Sugar Works.

The curing house for the Nail Bay Sugar Works is most likely a structure to the rear of the boiling house, which today is the first building encountered when walking into the site. It is a simple square building whose edges have deteriorated badly, with a doorway facing the boiling house and no other structural features except ventilation slits in the walls (**Photo 80**).

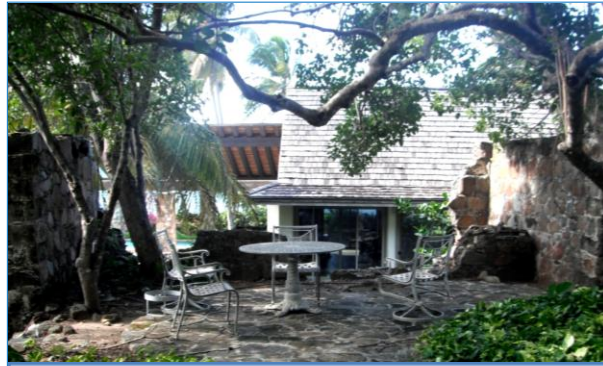
Photo 81. Nail Bay II Sugar Works.

now via a modern pathway landscaped on either side, leading to a stone patio used as a sitting area. To the front can be seen the copper battery wall beyond which is the modern residence and then the beach (**Photo 81**).

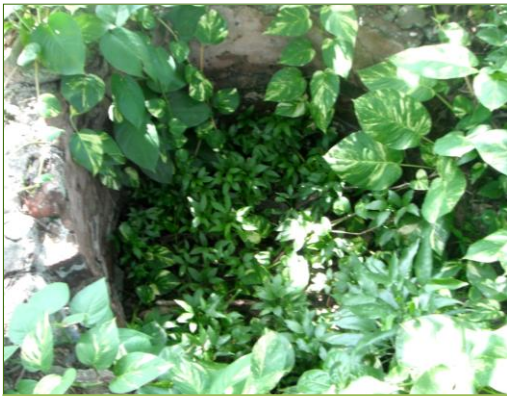
Photo 82. Nail Bay II Sugar Works.

At the entrance of the boiling house is a circular depression in the ground whose plaster-rendered interior betrays it as a former cistern, used to store cane juice prior to it being poured into the first copper (Photo 82).

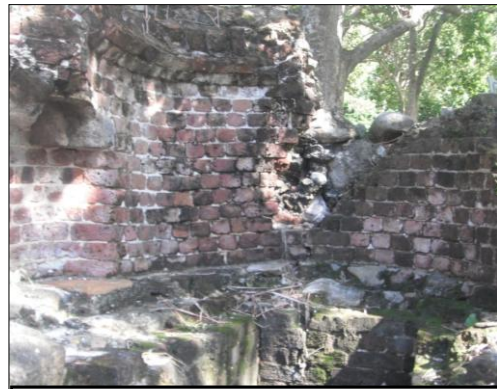
Photo 84. Nail Bay II Sugar Works.

From the exterior, the copper battery wall has collapsed leaving a visible cross section of the furnace stoking holes for the first and last copper (Photo 83). A portion of the red brick surround used to support the first copper is still visible (Photo 84), but the remainder of the copper support foundations have collapsed. To the right of the last copper can be seen the foundations for a rum still (Photo 85).

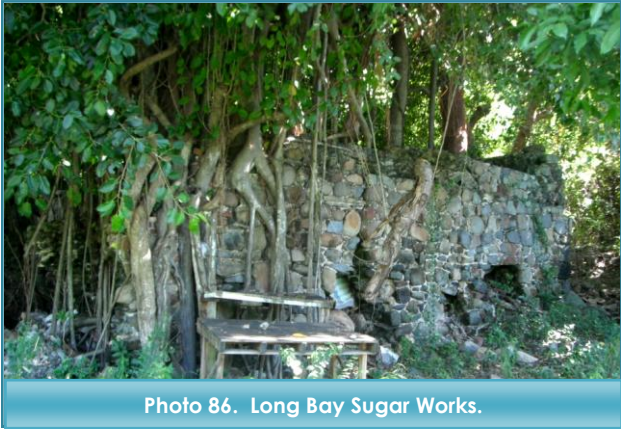
Photo 86. Long Bay Sugar Works.

Like the Nail Bay II site, the only visible remains of this sugar works is the boiling house, which is heavily overgrown but presents an ethereal view with a number of trees growing through its structure (Photo 86). The construction is far more rudimentary than the two previously described sugar works at Nail Bay, consisting predominantly of large andesite stones rendered with lime mortar.

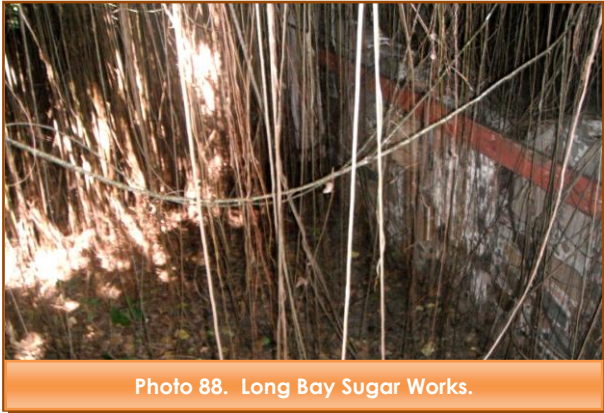
Photo 88. Long Bay Sugar Works.

To the rear of the main structure but still attached is a large cistern, which may be evidence that rum was once produced at this site. The cistern is relatively intact and covered in vines (Photo 88). To the side of the building is a mound with large stones which is all that remains of the animal round platform (Photo 89).

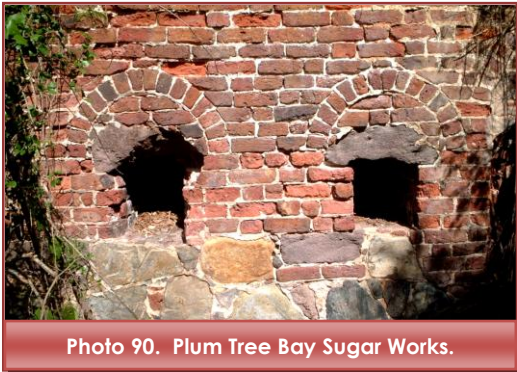
Photo 90. Plum Tree Bay Sugar Works.

The approach to the works is through the bush, which is quite dense in places. The boiling house is in good condition and composed of the usual andesite field stone and lime mortar aggregate. A profusion of red brick in the battery wall is in remarkable condition, both inside and out. The outside view presents a course of red brick running the length and height of the stoke holes; it is beautifully constructed and a testament to the masons who built it (Photo 90).

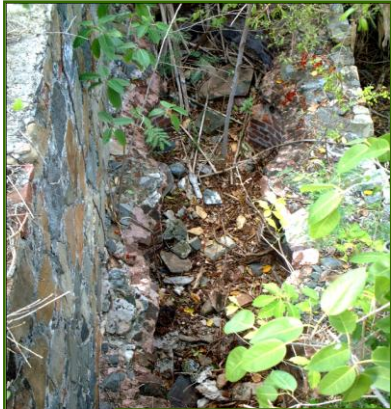
Photo 91. Plum Tree Bay Sugar Works.

The inside of this wall where the coppers once sat is in surprising condition considering that the large vats have been ripped out. The four circular foundation supports are still clearly visible and again beautifully fashioned in red brick (Photo 91). Looking down the line it is easy to imagine how the coppers would have been placed in their foundations and heated from below. The rims where the lip of each copper would have rested are still clearly visible (Photo 92), whilst beneath—in

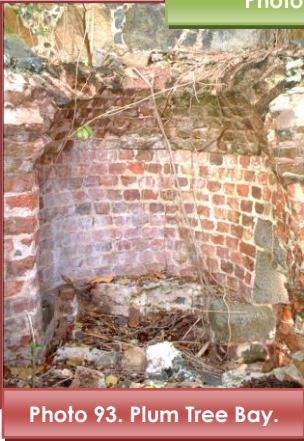
Photo 93. Plum Tree Bay.

the furnace area—the red brick foundations are still firmly holding together (Photo 93).

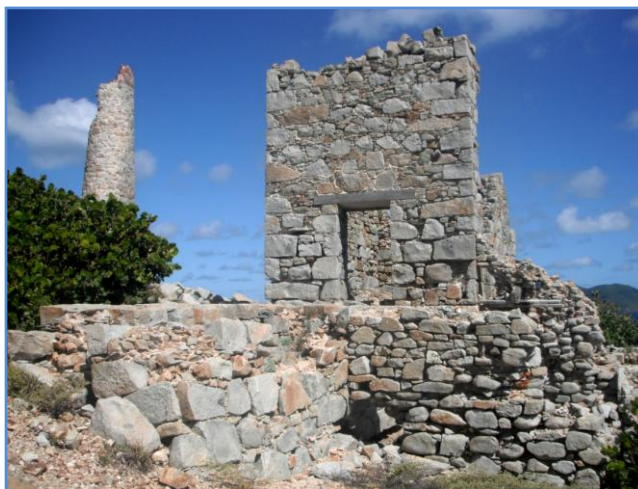
Photo 94. The Copper Mine Engine House.

The largest individual structure is the engine house, which presents an iconic view, nestling approximately 80 feet above sea level

(**Photo 94**). Built from andesite field stone bound with lime mortar, this was once where the single cylinder beam engine was housed, similar to one on display at the Poldark Mining Museum near Helston in Cornwall, England (Holt, 2003). The engine was used to pump water and raise ore from the mine shafts and was powered by a boiler below, which still sits in its original foundation but is heavily deteriorated (**Photo 95**). The chimney stack (**Photo 96**), which vented the coal smoke from the boiler furnace, is of typical Cornish construction with a red brick cap (Burt, 1982).

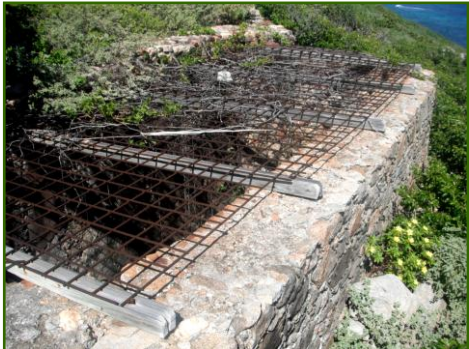
Photo 97. Cistern surface, Copper Mine.

Other structures include a large cistern which by today's standards is still massive. Covered by a protective iron grate (Photo 97), the cistern is extremely deep (Photo 98) and was filled from a catchment platform to the rear (Photo 99). Water from this cistern was required for general use but more specifically to fill the thirsty boiler which powered the beam engine.

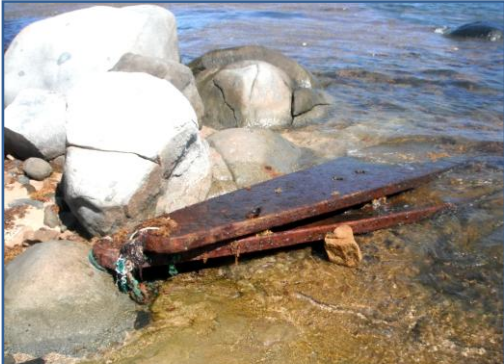
Photo 101. Beam engine lever, Copper Mine Bay

The beam rests half in and half out of the water in two pieces (Photo 101). This important piece of Virgin Gorda history and British Industrial Revolution technology will require *in situ* conservation, probably employing sacrificial anodes\* to stabilise the iron's integrity before removing it to a stable environment.

Issues, Conflicts, and Areas of Concern	Impacts of No Action/No Change	Short-term Options Long-term Recommendations
<p><b>ISSUE FIVE—<u>Beam Engine Lever at Copper Mine Bay</u></b></p> <p>Another artefact from the island’s copper mining era, the beam engine lever lies partially submerged in the waters of Copper Mine Bay.</p>	<p>Survival of the artefact is in jeopardy if not properly conserved.</p>	<p><b>SHORT-TERM OPTIONS</b></p> <ol style="list-style-type: none"> <li>1. Research is needed on <i>in situ</i> methods of conservation, in particular, on the attachment of sacrificial anodes to stabilise the artefact’s iron integrity. Once researched, the most appropriate <i>in situ</i> conservation method should be carried out under the supervision of the National Parks Trust.</li> </ol> <p><b>LONG-TERM RECOMMENDATIONS</b></p> <ol style="list-style-type: none"> <li>1. Once <i>In situ</i> conservation has taken place, the artefact needs to be removed to an appropriate site for long-term preservation.</li> </ol>

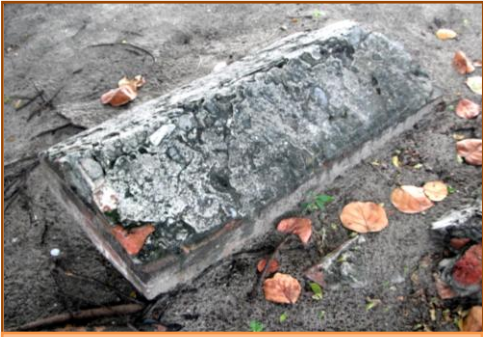
Photo 103. Tomb, St. Thomas Bay

Most of the graves present are narrow red brick monuments which have a surface rendering of lime mortar finishing in a triangular shape (Photo 103). Some of the graves are close together suggesting the interment of a single family.

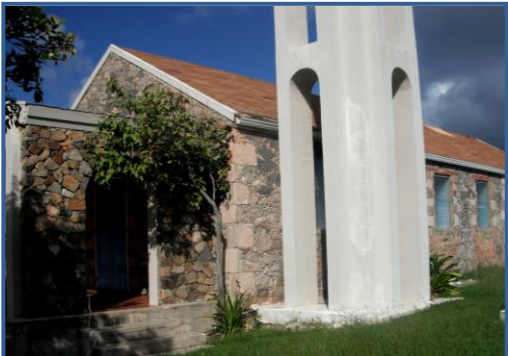
Photo 104. St. Mary's Episcopal Church.

This beautiful little Anglican church lies nestled inland of Spanish Town (Figure 19) with a graveyard surrounding it on one side and parking space on the other. The main building was constructed from andesite field stone and lime mortar in approximately 1875 (Koladis, 1976), but has been added to since with an extension to the rear, porch at the front, and bell tower on the south side (Photo 104). The main structure now has windows on either side, but the construction variant beneath each of these windows suggests that they were once doors. Red brick has been used to accentuate the window ledges and door frames of the original building.

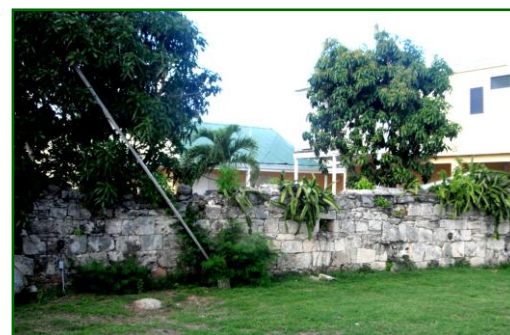
Photo 109. South-facing wall, Olde Yard Inn.

Three sides of the building are composed of andesite field stone, whilst one side is almost exclusively composed of carved ashlar blocks on the exterior facing wall (**Photo 109**). The interior is derelict and used today for storage.

<p><b>ISSUE NINE—<u>Olde Yard Inn Building Base</u></b></p> <p>The immediate environment surrounding this site has already been extensively developed.</p>	<p>If steps are not taken to enhance the importance of the ruins at the site, they will undoubtedly suffer further degradation.</p>	<p><b>SHORT-TERM OPTIONS</b></p> <ol style="list-style-type: none"> <li>1. As an immediate action, the solar panels currently stored in the interior of the building should be removed. Additionally, the area surrounding the ruin could be re-landscaped with local plants and vegetation.</li> </ol> <p><b>LONG-TERM RECOMMENDATIONS</b></p> <ol style="list-style-type: none"> <li>1. The site would be significantly enhanced if a professional mason could be employed to consolidate the ruins, using traditional materials.</li> <li>2. The ruins need to be promoted as an integral part of the more modern complex. An interpretation board might be prepared to illustrate the history of the area and to suggest what the ruin might have been within the context of the site's historical development.</li> </ol>

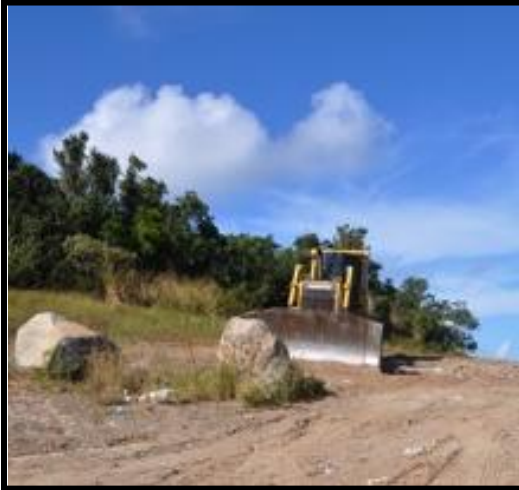
**Photo 114.**

Bulldozer at Virgin Gorda landfill site.

A new bulldozer was purchased in 2008 after the old machine had been out of order for many years (**Photo 114**). A few breakdowns of the new bulldozer occurred in 2011, and during such periods a bulldozer had to be rented. The bulldozer is used to push waste to the perimeter of the site and also to cover waste with soil to reduce vector issues such as rats, flies and mosquitoes.

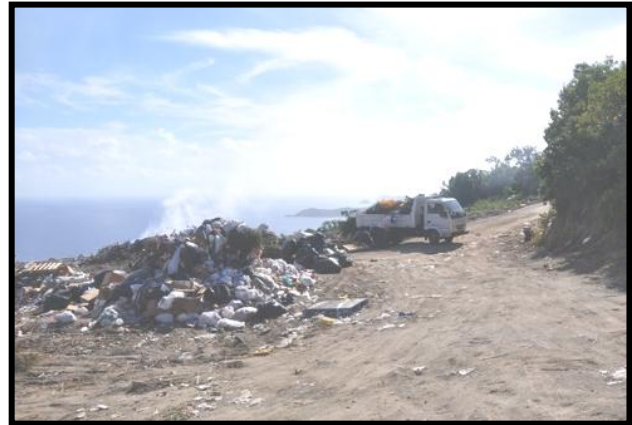
**Photo 115.**

The road to the waste disposal site on Virgin Gorda.

The road to the landfill was in severe disrepair for many years but has now been concreted to provide better access. Cracks are present in the concrete, but it seems to be holding except for the lower portion of the road. There are problems with waste being dumped close to the road, leaving little space for trucks to turn around and thus creating a safety hazard (**Photo 115**).

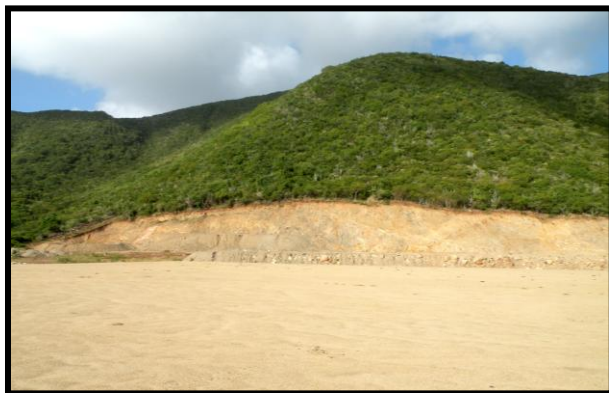
**Photo 123.**

accommodate greenhouses. The fill was excavated from the base of a steep hillside (**Photo 123**). In its incomplete state, it is exposed to severe erosion, which is further aggravated by the fact that no erosion control measures were applied and the little sediment control measures that exist remain dysfunctional (**Photo 124** and **Photo 125**). This situation is clearly impacting the important nearby Fisheries Protected Area located along Taylor Bay and Handsome Bay.

Photo is taken standing on top of the 25,000 m<sup>2</sup> platform for the unfinished greenhouses at South Sound, looking inland. Most of the fill material for the platform was excavated from the hillside. The entire surface area of the excavated hill has no protection from rain-induced erosion and wind-blown sediments.

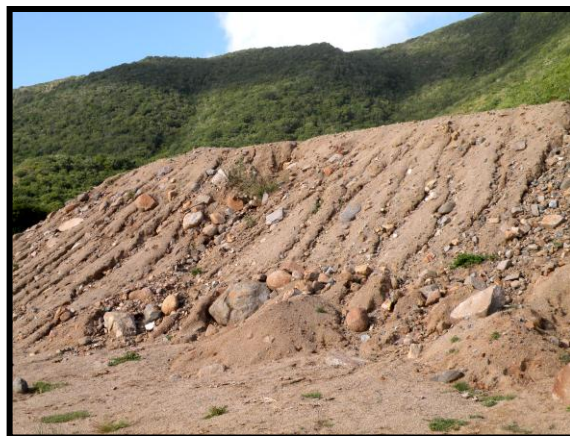
**Photo 124.**

The edge of the platform constructed at the site of the unfinished greenhouses is about 4 m (13 ft) in height, and its steep slopes show signs of intense "rill" erosion.

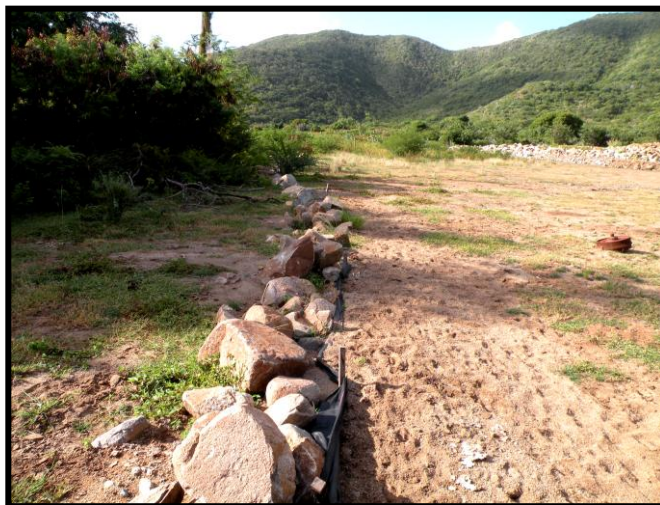
**Photo 125.**

Dysfunctional silt fences downstream from the greenhouse development have little effect for sediment retention. The barrier was trampled by livestock and left in disrepair.

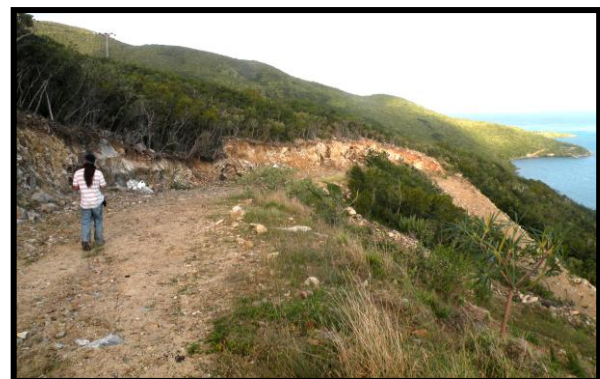
**Photo 127.**

The first major switchback along the upper section of the Leverick Bay public road. Below the switchback, the road dramatically steepens.

1. Except for a few segments such as the end segment which generally follows the contours, most of the road is cut into very steep topography (**Photo 127**).
2. The clearing for a wide road bed has necessitated deep hillside cuts which have:
  - (a) Scarred the landscape (**Photo 126**);
  - (b) Adversely impacted biodiversity (see also Chapter 4, Section 4.5.1);
  - (c) Exposed more bare ground to potential erosion (**Photo 128**).
3. The entire road segment was examined and there was a noticeable absence of any erosion and sediment control measures (**Photo 129**).
4. No permanent or temporary storm drainage structures were in place for the road.

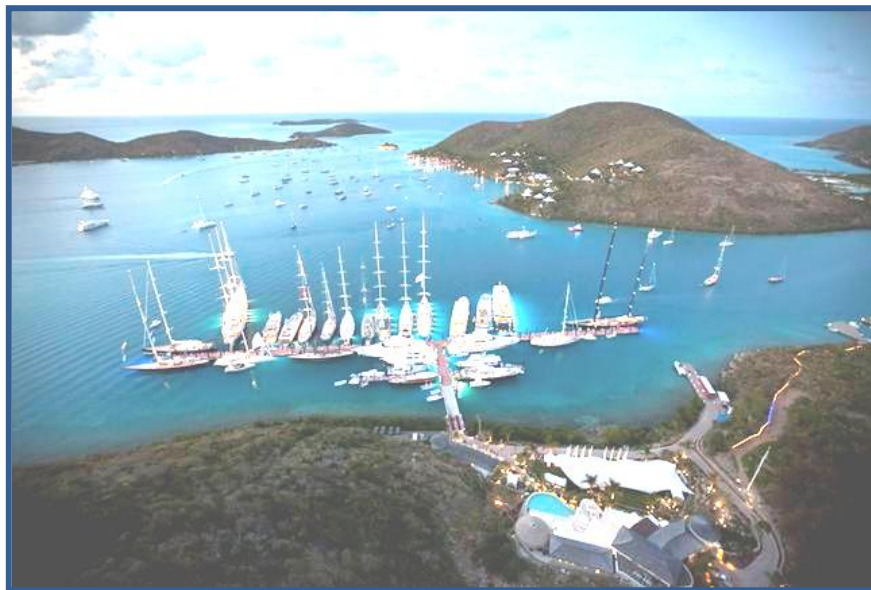
**Photo 136.**

Aerial view of the Yacht Club Costa Smerelda (YCCS) looking north, with the Bitter End Yacht Club in the background (source: Jeff Brown Superyacht Media).

The North Sound's newest component in the mix of activities and enterprises that make up the area's economy is the addition of mega-yachting. For a number of years, through two different administrations, a tacit government policy has been in place to encourage super-yachting in the Territory. The newly opened (January 2012) Yacht Club Costa Smeralda (YCCS) was built for larger yachts, with a state-of-the-art marina that can accommodate 38 yachts up to 100 metres (328 ft) in length and a draft of up to six metres (20 ft). Across the water from YCCS, the Bitter End Yacht Club has added a new dock in part to take advantage of the growing mega-yacht market (**Photo 136**).
